REPAIR PROCEDURES

(1997 and 1998 Generation II tail light assembly)
P/N F7LY 13A565 AAA thru AAF

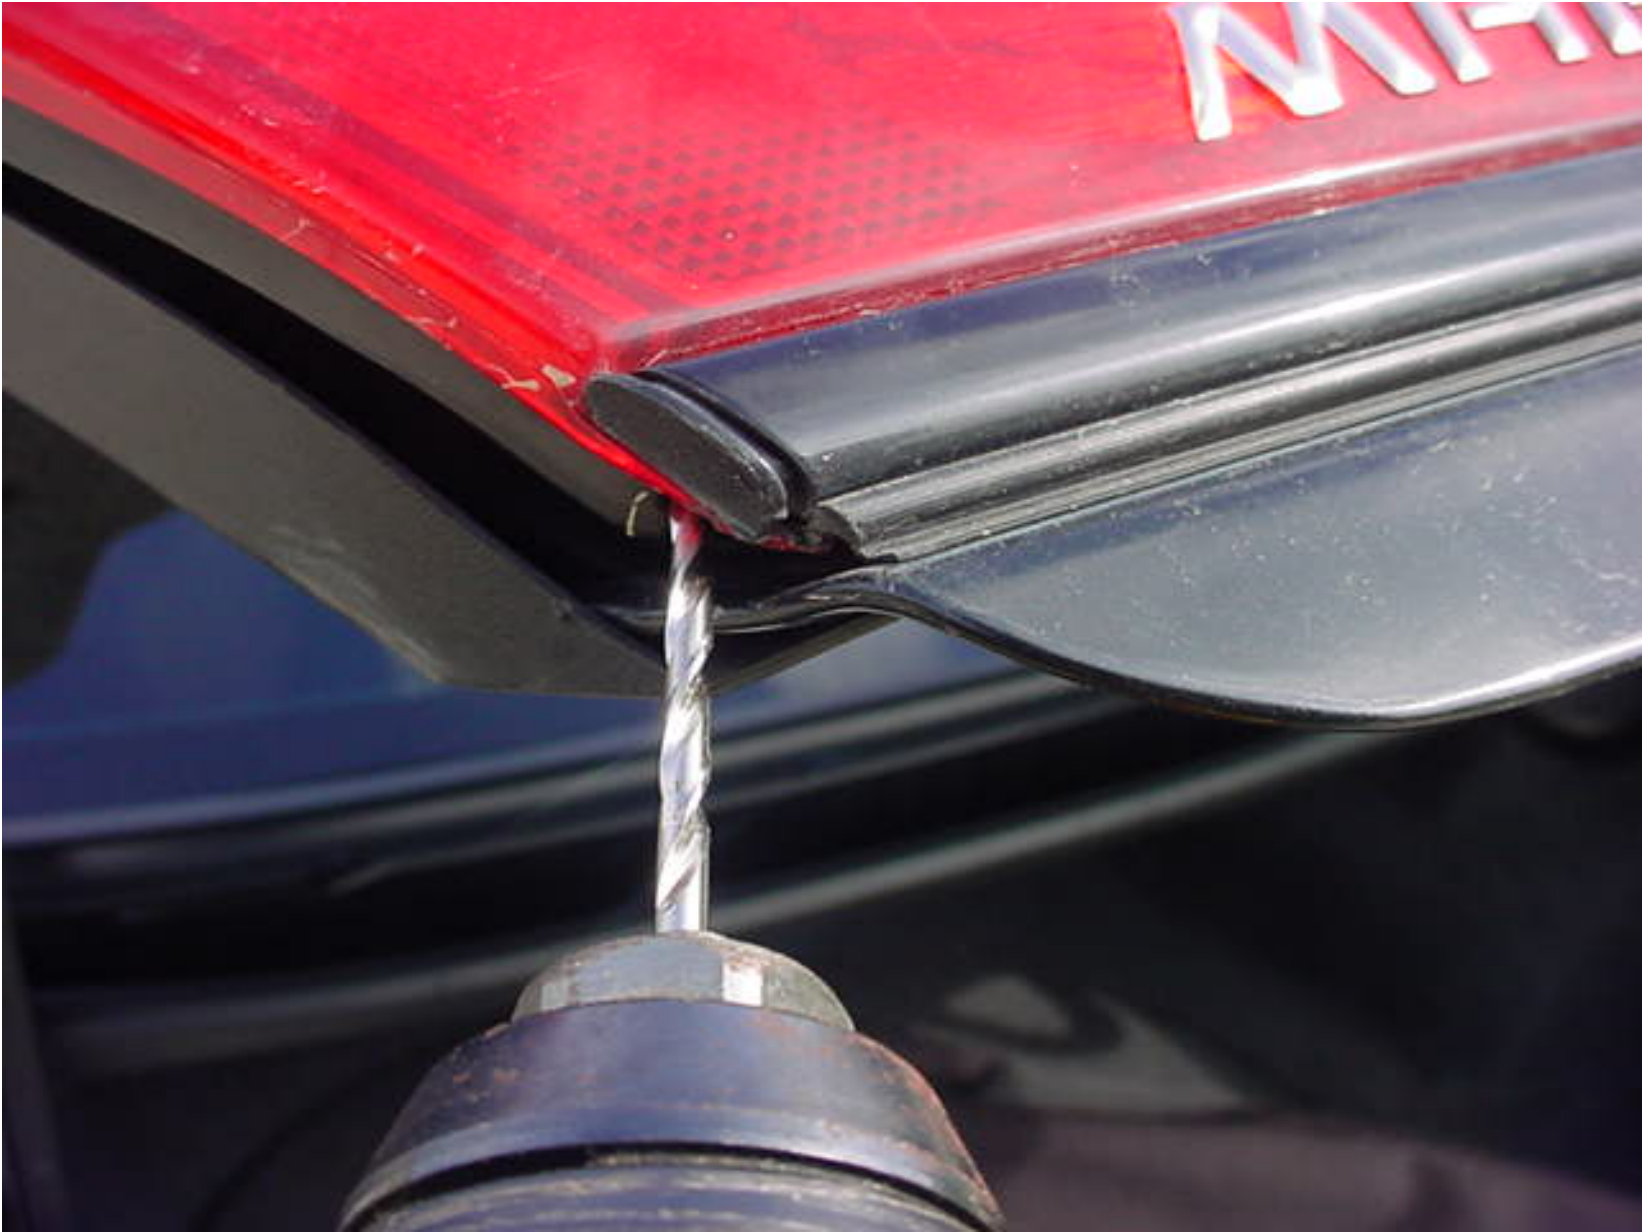
Figure 1

If there is moisture in the light assembly; every time you open the trunk lid water is allowed to make its way to the top of the light where the HID (neon) bulb resides.

There is a wire mesh inside the housing that is grounded and this wire mesh surrounds the light diffuser running the length of the neon bulb. Water which is a conductor allows the high voltage connections to short to ground via this wire mesh, damaging the inverter. The following is a way to resolve this issue.

This can be done by drilling a 1/8 holes in each lower corner of the light assembly. (Light assembly does not have to be removed) Drill through the light assembly as close to the black plastic backing as possible.
